## **Supervisor at Plastics Company Crushed in Injection Molding Machine**

### **SUMMARY**

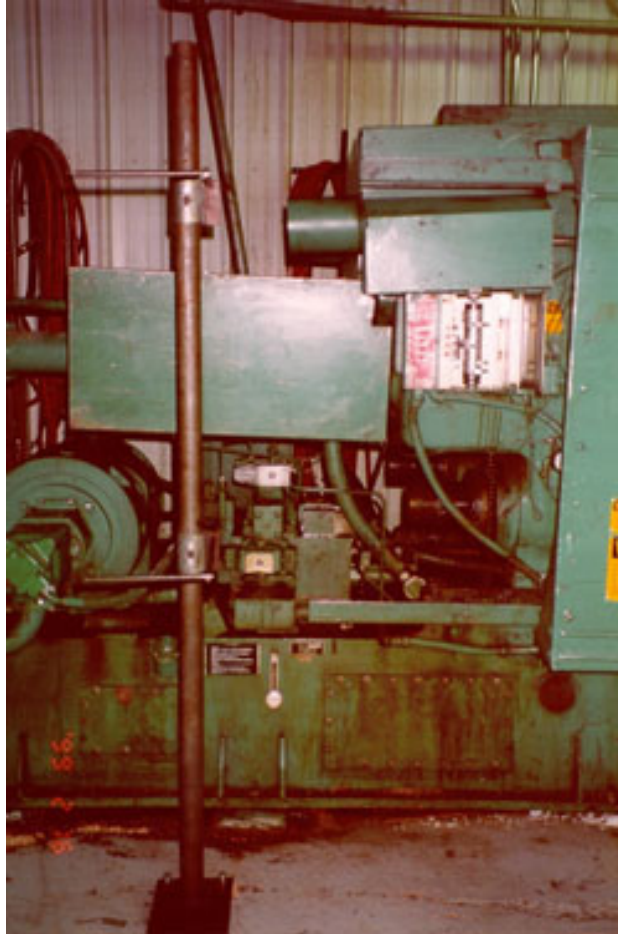
**Figure 1. This photo was taken after the machine guards were replaced.**
